#23-NA-115: Ticking, Tapping or Snapping Noise from Engine - 5.5L RPO LT6 Realign Camshaft Caps as Required - (Jun 28, 2023)

Brand:	Model:	Model Year:		VIN:		Engine:	Transmission:
		from	to	from	to		
Chevrolet	Corvette	2023	2023	—	—	5.5L (RPO LT6)	—

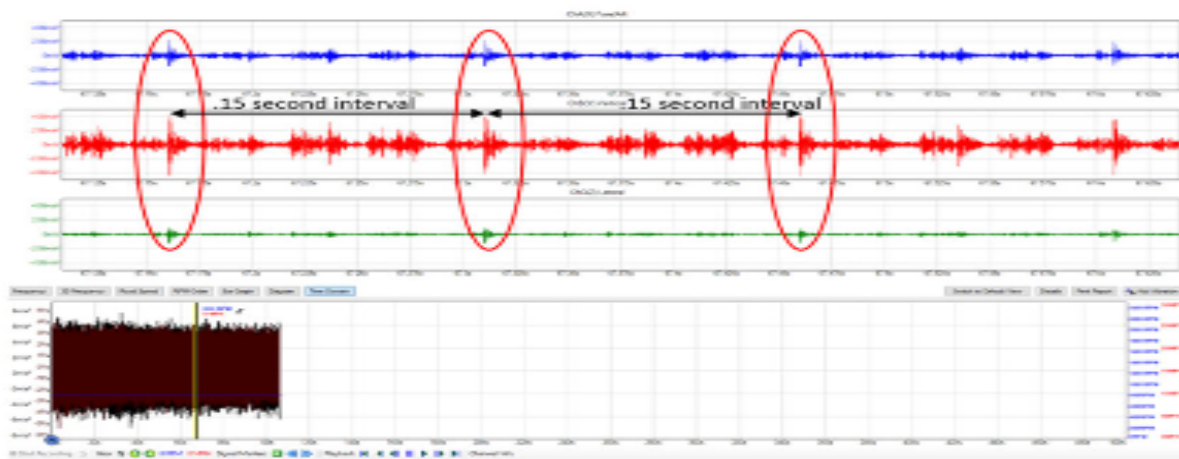
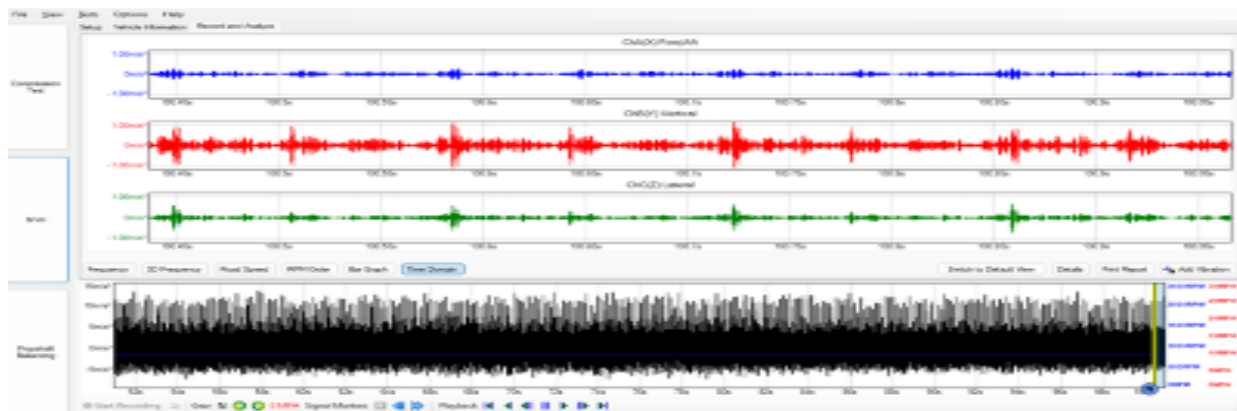
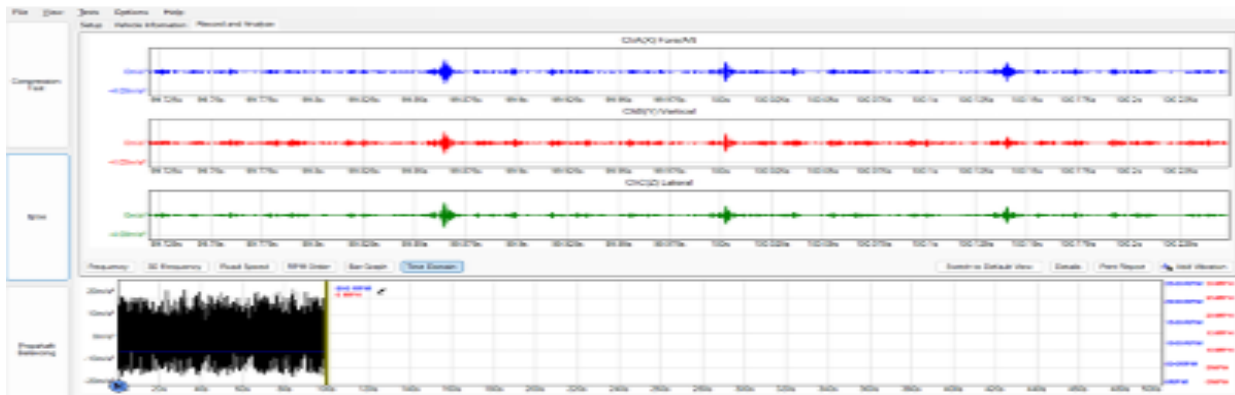
Examples of Tick:

1. Right click in the time domain display and change the display mode to single.
2. If scales on the left end for each channel are not ranging from -4 m/s² to 4 m/s², right click in the time domain display and select "reset scale."
3. Pull the yellow window cursors on the bottom in as close together as they will go.
4. Look at the channel lines in the time domain window for ticks with a .15s gap between them.
⇒ Compare to the examples below for an engine with a tick and an engine without a tick:

Once it is determined which bank the noise is coming from, it will be necessary to follow the service procedure below to adjust the camshaft cap torque.
